SmartMelter® Blind Trial at a Tableware Furnace

智慧窑炉®在器皿玻璃窑炉盲试

Libbey Glass had a tableware furnace that was scheduled for a drain and rebuild. SmartMelter® had monitored this furnace for about two years and indicated relatively healthy sidewalls; but the condition of other areas, outside the sidewalls, required an earlier rebuild of the furnace. Before the drain, the SmartMelter® team performed surveys of both the sidewall refractory thickness at the metal line and glass penetration into the sidewall insulation. These measurements were reported before shutdown, near end of life for the campaign.

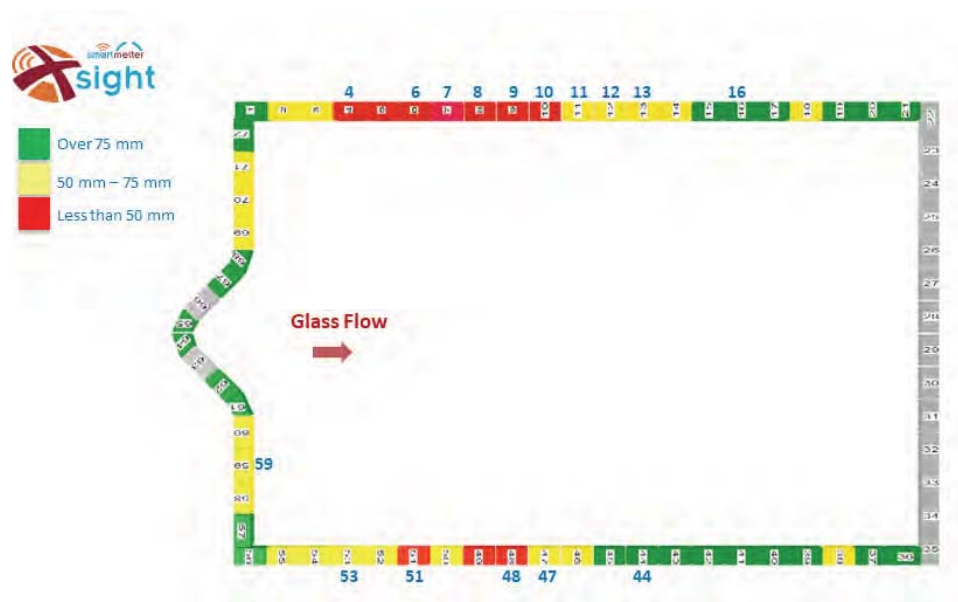
Figure 1
Furnace Layout and Measurement Spots.

Measurements of the fused cast AZS were taken on the left and right sidewalls, doghouse and charging end wall at the metal line for thickness (see Figure 1)

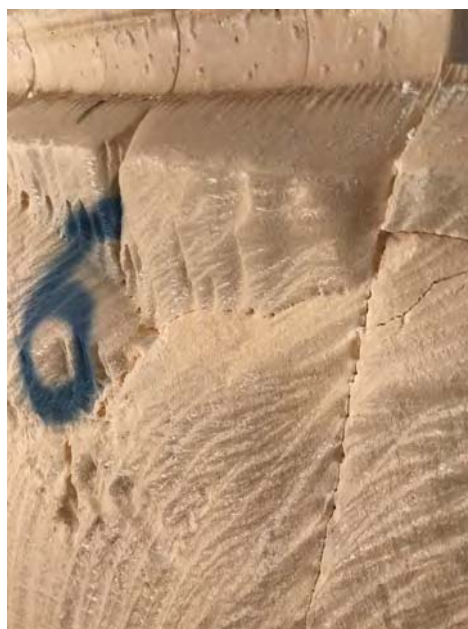
Figure 2
Typical Sidewall Erosion Pattern at
the Metal Line..

图 2
池壁液位线处典型的被侵蚀特征

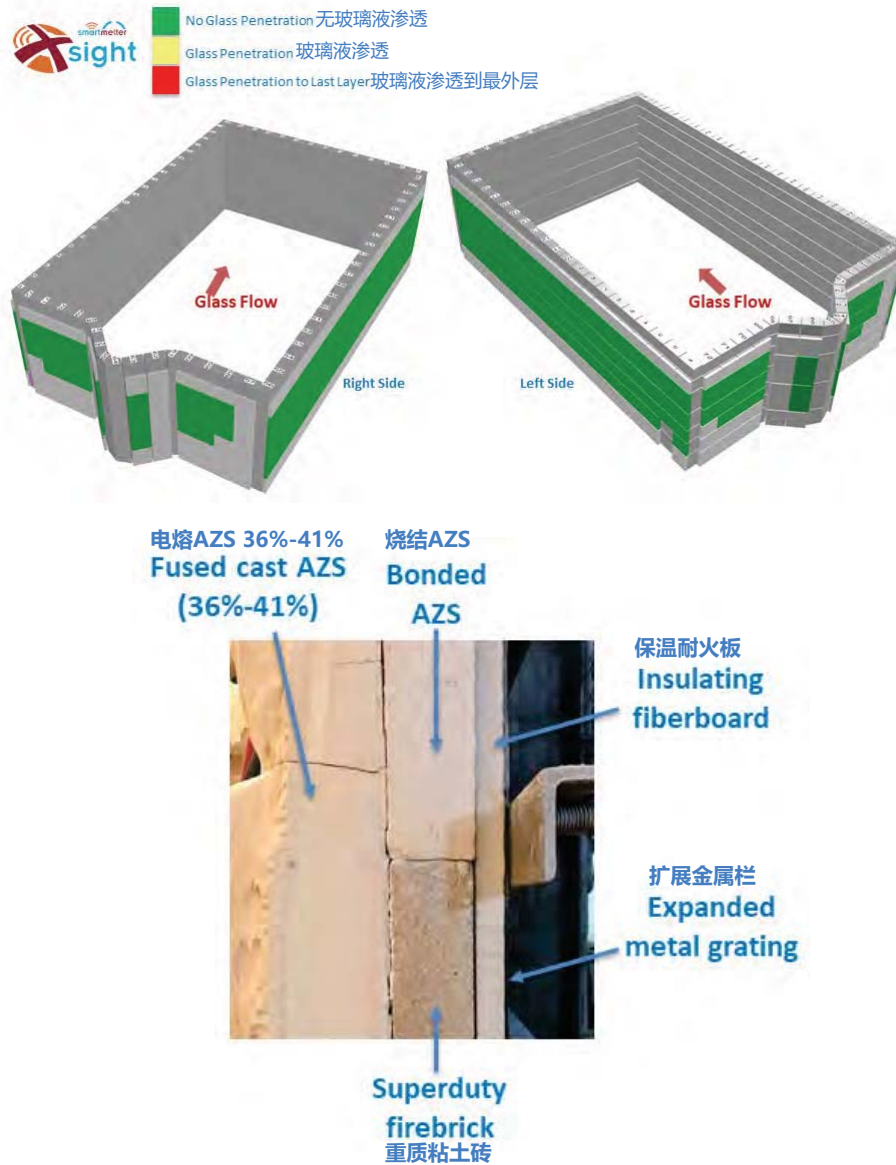
Figure 5
Visualization of Sidewall Insulation Inspection in Xsight software.

There was no glass penetration into the sidewall insulation, indicated by visual inspection from inside the drained furnace and by removal of the insulation during demolition. The SmartMelter® results reported no glass penetration on the furnace. Observations from inside the furnace showed erosion at joints, but all AZS sidewalls were intact and had no breach.
