Responding to emergencies two years in advance

The introduction of radar-based refractory inspection in 2017 brought new insight into the rate of wear of the inner insulation and protection layers. Data from nearly 1 million measurements on over 300 furnaces shows that once glass infiltration begins, a furnace can continue to operate much longer than anticipated. Alex Ruege and Jon Wechsel from PaneraTech explain what they have learned.

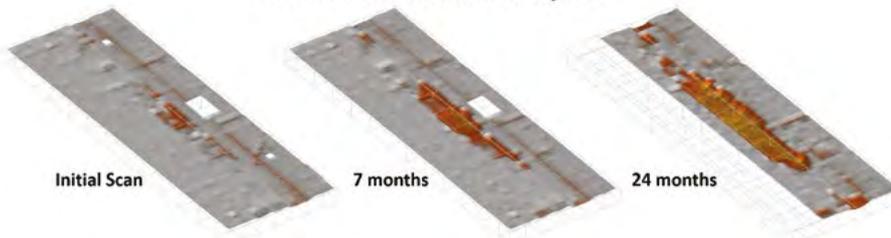
Float Furnace Bottom Example 1

Radar mapping of showing the progression of glass penetration into a float furnace bottom.

Example 1: Float furnace bottom repaired two years after glass detected

The first mapping done on this bottom indicated wear into the outer clay flux. After two years, the thickness reduced by 120mm at the worst locations on the bottom. However, we observed that the affected area spread laterally by seven times of the original area over the course of those two years. Water and air cooling was applied on the bottom surface and was gradually increased and changed as guided by the radar mappings. These mappings allowed the presence of glass infiltration to be known by the manufacturer and proper maintenance plans were set in place well in advance of the needed repair, which occurred two years after the initial mapping where glass infiltration was discovered.

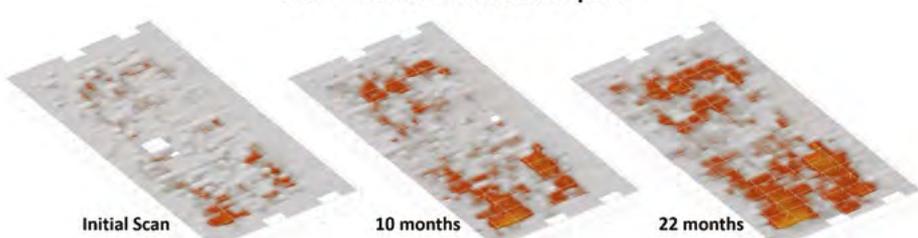
Float Furnace Bottom Example 2

Example 2: Float furnace bottom repaired 22 months after glass detected

As in the first example, early-stage glass penetration was found in the initial radar mapping in this float furnace's clay flux bottom layer. This glass penetration also spread significantly over a period of nearly two years. However, the thinnest area only lost 50mm of material. Air cooling was applied on the bottom surface after the initial radar mappings. Once again, the furnace was safely shut down and repaired 22 months after the initial mapping.

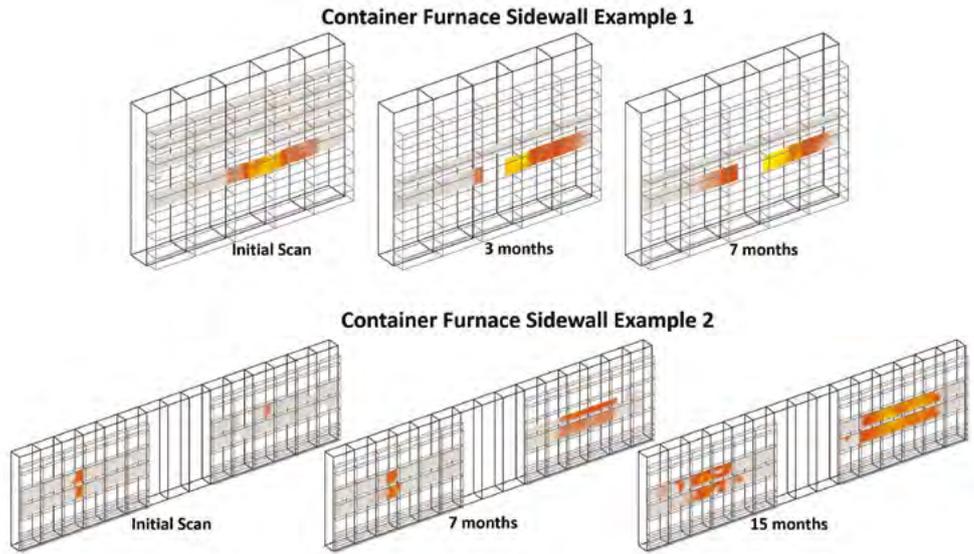
Radar mapping of glass penetration progression into a container furnace sidewall.

On a container furnace sidewall, which was composed of bonded AZS, firebrick and insulation board, initial radar mappings of the area showed deep infiltration into the bonded AZS layers in front of the outer firebrick layer. Over a period of seven months, only 8mm of the bonded AZS was lost at the worst locations. The outer insulation board was removed, and cooling was applied in these concern areas. A sidewall repair of the area took place seven months after the initial discovery and furnace operations continued.

On a similar container furnace sidewall, the first radar mapping of a sidewall area discovered the early stages of glass infiltration into the bonded AZS layer. After 15 months, the worst-case location only lost 10mm of the bonded AZS. However, the affected area increased dramatically, spreading from only two tank blocks to 10 blocks. The outer firebrick layer was removed, and a significant amount of air cooling was applied to the bonded surface. Soon after the last radar mapping, the furnace was safely shut down and repaired.
