Furnace Life Optimization Solution

Cardinal Glass Avoids an Expensive Surprise with **SmartMelter**[®]

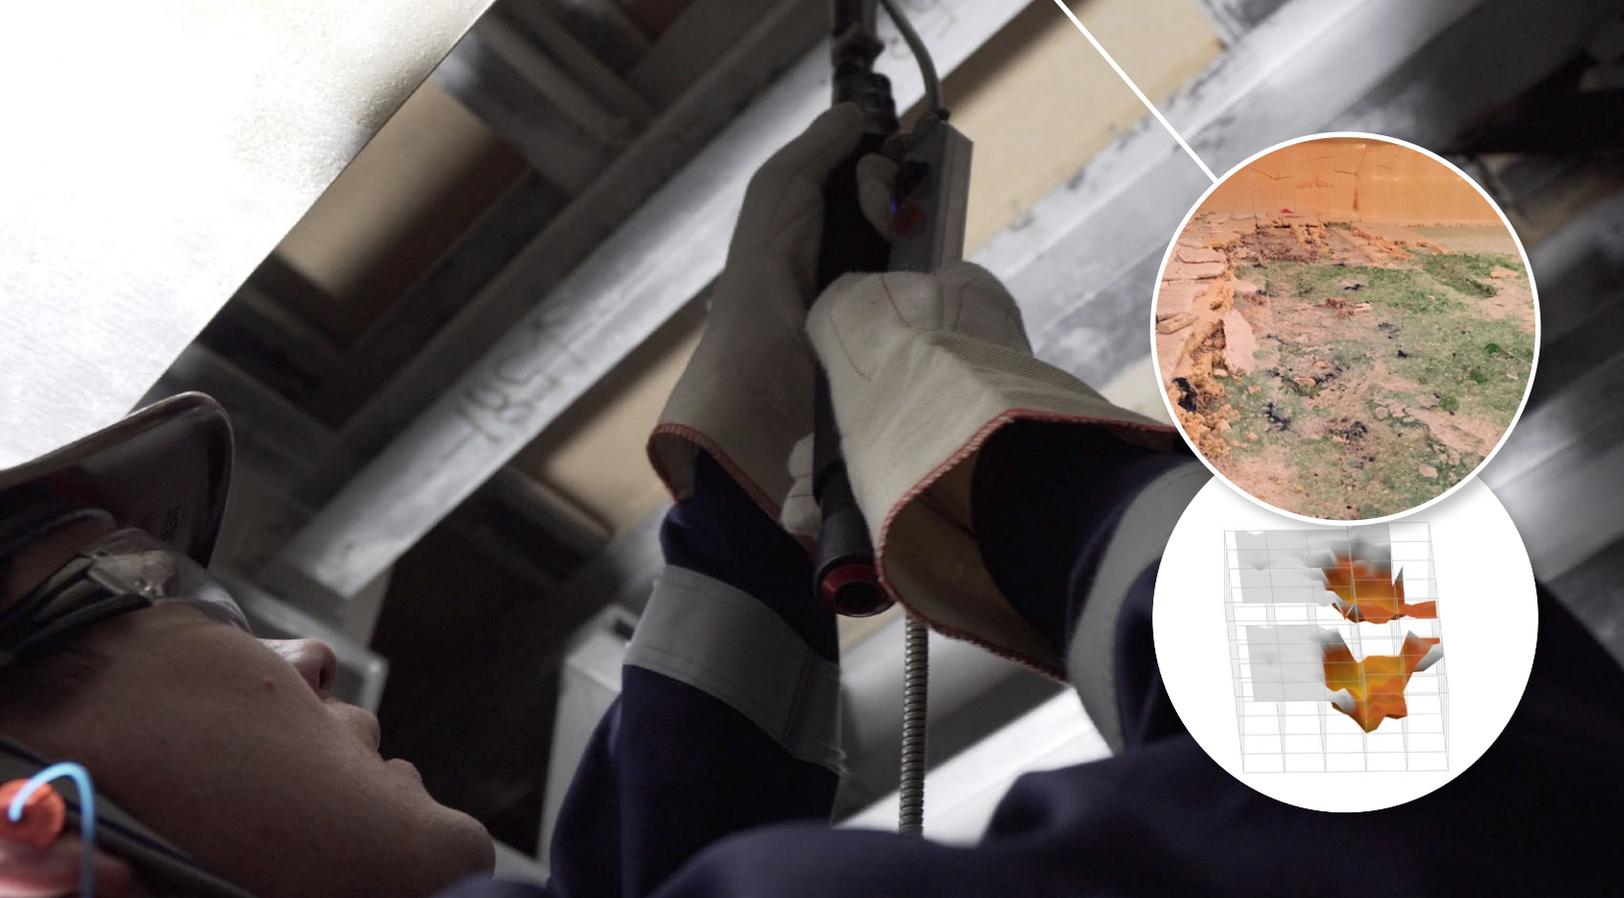
The first full inspection on a float glass furnace bottom revealed some shocking information. There were areas that were worn much thinner than expected. The expectations for the furnace life of this specific furnace design placed the next rebuild date at least three years away. However, according to the SmartMelter® data, a cold repair would be necessary in less than a year.

Because of the SmartMelter® report, Cardinal was able to avoid the cost and chaos of an unexpected leak. They scheduled a cold repair in eight months, but were prepared to shut down for repair sooner if necessary. The contract was ready, labor was scheduled, and materials were ordered and on site a few months in advance. Cardinal employed maintenance techniques to slow the erosion and monitored the condition of the furnace bottom with regular SmartMelter® inspections. The furnace remained in operation until the new scheduled repair date, and all customer orders were fulfilled.
