Refractory Thickness Sensor (RTS)
耐火砖厚度探测传感器 (RTS)

Blind Trial at a Float Line
浮法线盲试

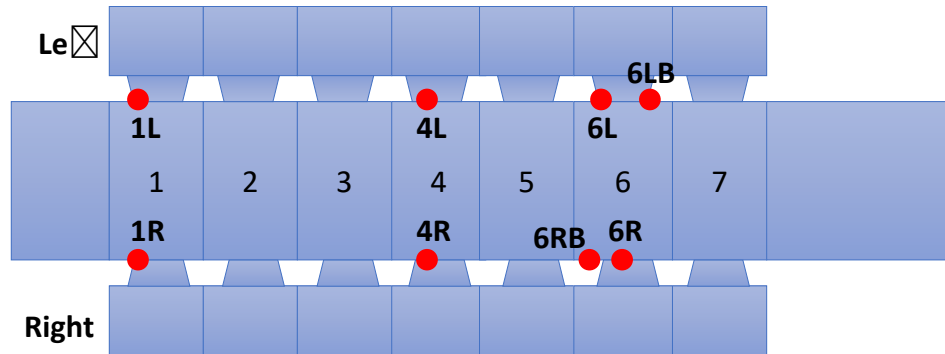
Figure 2
Furnace Layout and Measurement Spots

The float line furnace was a cross-fired furnace. Measurements were taken on a total of 8 blocks (see Figure 2) at both left and right side of ports 1, 4 and 6

这座浮法线为横火焰窑炉，测量点选择在1, 4和6号小炉的左右两侧的共8块耐火砖处(见图2示)

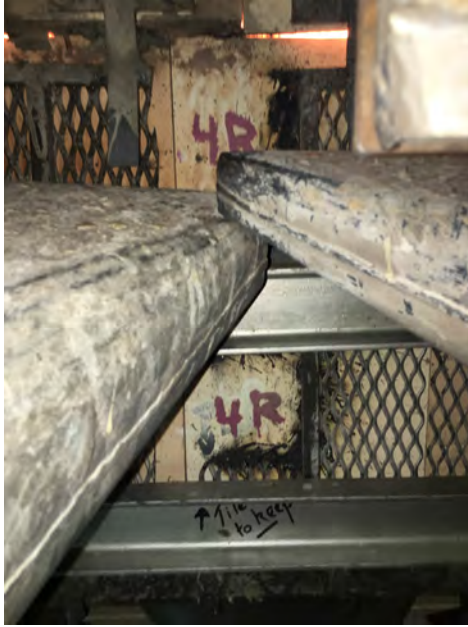
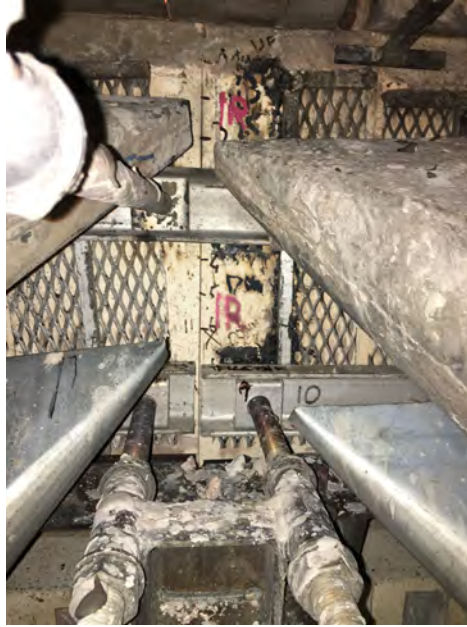
Figure 4
Each measurement spot was marked properly

Gratings that were holding the overcoat blocks in place were cut prior to the measurements to allow access to the exposed AZS as shown in Figure 4.

图4所示,保持贴砖的格栅在测量前已经被提前切割以便传感器接触到裸露的AZS砖面。

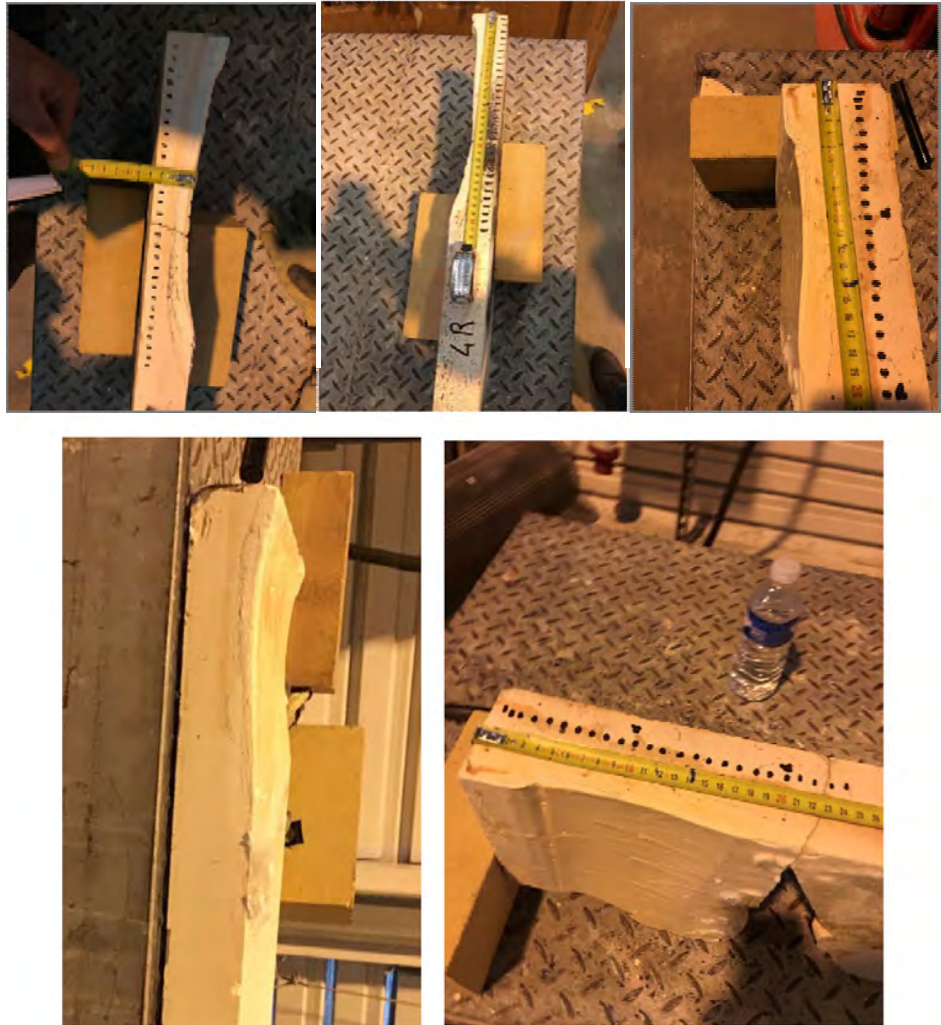
Figure 6
Pictures of Some of the Blocks
Recovered During Hot Repair

After lowering the glass level, all of the blocks were successfully recovered. The actual thickness of each block was measured with the float line manufacturer team. The original tank block had completely eroded at the glass level for most of the blocks.

在降低玻璃液位以后，所有的耐火砖被成功复原，浮法玻璃线的人员对每块砖实际的残余厚度进行了测量，液位线处的几乎所有原池壁砖被完全侵蚀掉了。
