Furnance Bottom Thickness
窑炉池底厚度

Blind Trial at a Float Line
浮法线盲试

A major US-based float glass manufacturer approached PaneraTech to use our SmartMelter solution to measure the residual thickness of the furnace bottom on a float line furnace. The float furnace was near the end of the campaign, and the health of the bottom was of great concern for the manufacturer. Eight months before the planned shutdown date, PaneraTech performed an initial assessment of the furnace bottom. PaneraTech performed several surveys leading up to the planned shut-down to map the residual thickness of the furnace bottom

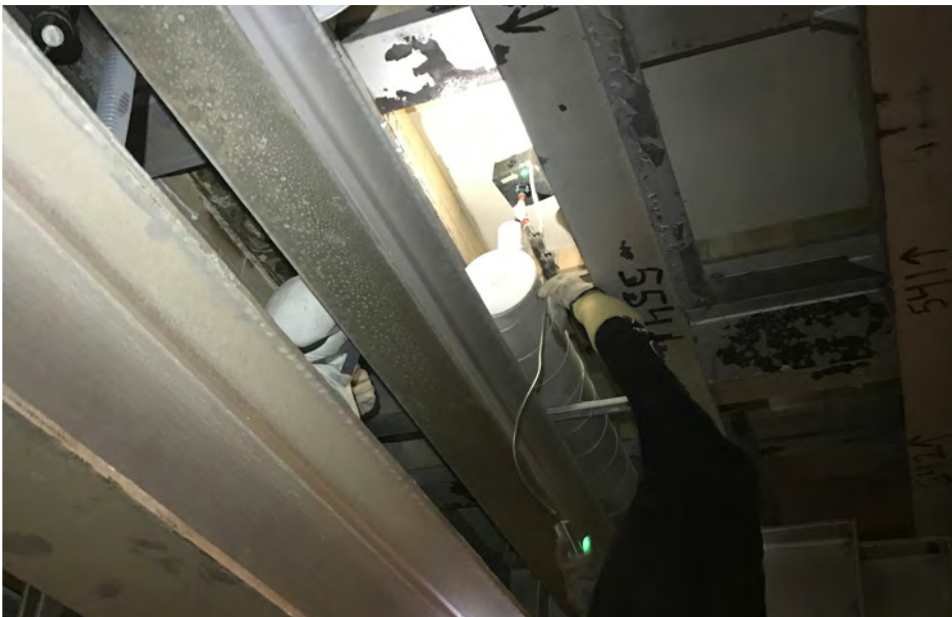
Figure 1
SmartMelter Furnace Bottom
Inspection at a Float Line

SmartMelter在浮法窑底的探测

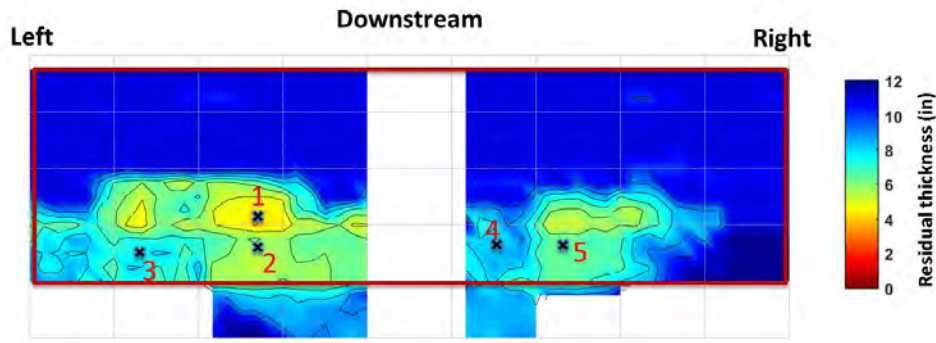
Before the drain, the data was obtained so that a 3-D view of the erosion profile on the furnace bottom could be created. A top view of this profile is shown in Figure 3. Five locations were measured for comparison and are marked in the figure. Note that the erosion profile indicates a minimum residual thickness of 99 mm (3.9 in) near spot 1. The blocks in this area show strong erosion, where the original thickness of the block was 280 mm (11 in). A photograph of this same area, highlighted in red, is shown in Figure 4. It is clear from the photograph that the areas of clay flux penetration correspond to the areas indicated in the 3-D erosion view.

在窑炉放水前，利用收集到的探测数据创建了一个三维可视化的窑底侵蚀地图，图3是侵蚀地图的顶视，其中有5个位置的实测数据与图中对应位置的数据进行了对比。请注意在测点1附近的侵蚀轮廓显示最小的残余厚度仅剩99mm(3.9英寸)，这个区域的砖有严重的侵蚀，其粘土底砖的原始厚度为280mm(11英寸)。在同一区域的照片中如图4所示红框范围内的被玻璃液穿透的情况与三维侵蚀图显示是一致的。

Figure 3
Top view of clay flux erosion obtained before furnace drain

图 3
窑炉放水前池底粘土保温砖侵蚀图顶视

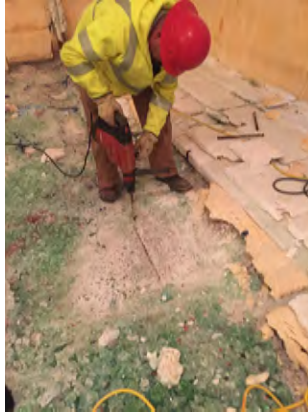
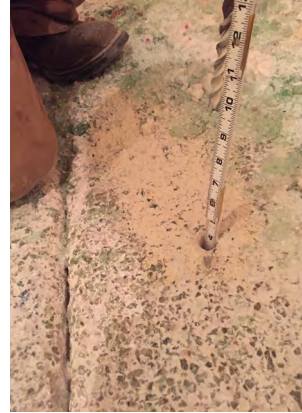
Figure 6

After the drain, several spots were chosen by the float glass manufacturer for comparison with the SmartMelter results. The remaining cold glass was removed and these spots were drilled. The actual thickness of each block was measured by the float line manufacturer team. In the spots that were examined, the original AZS paver blocks had eroded and glass had penetrated into the clay flux. The SmartMelter sensor successfully measured the thickness of the residual clay flux for these five spots within 0 - 5 mm (0.2 inch) accuracy as shown in Table 1. The five blocks had residual thicknesses of 99 mm to 208 mm .

在窑炉放水后，浮法玻璃制造商选择了几个点实测来与SmartMelter的探测结果对比，这几个点上的残余冷玻璃被去除并钻孔实测，每块被钻孔的砖的实际厚度被浮法玻璃制造商的人员测量验证，在这些测点商原有的AZS铺面砖已经被玻璃液完全侵蚀并且玻璃液渗透到粘土保温层中。SmartMelter的探测传感器成功地探测到了这5个测点保温层粘土砖残余厚度，与实测对比精度达到0-5mm(0.2英寸) 如表1所示，5个测点的砖的残余厚度测得为99mm至208mm。

Validation of SmartMelter with glass removal, drilling and measurement of actual thickness

SmartMelter验证，通过与去除玻璃，钻孔后的实测厚度数据对比
