Furnace Life Optimization Solution

Libbey Furnace Using SmartMelter® Increases Campaign Life by 25%

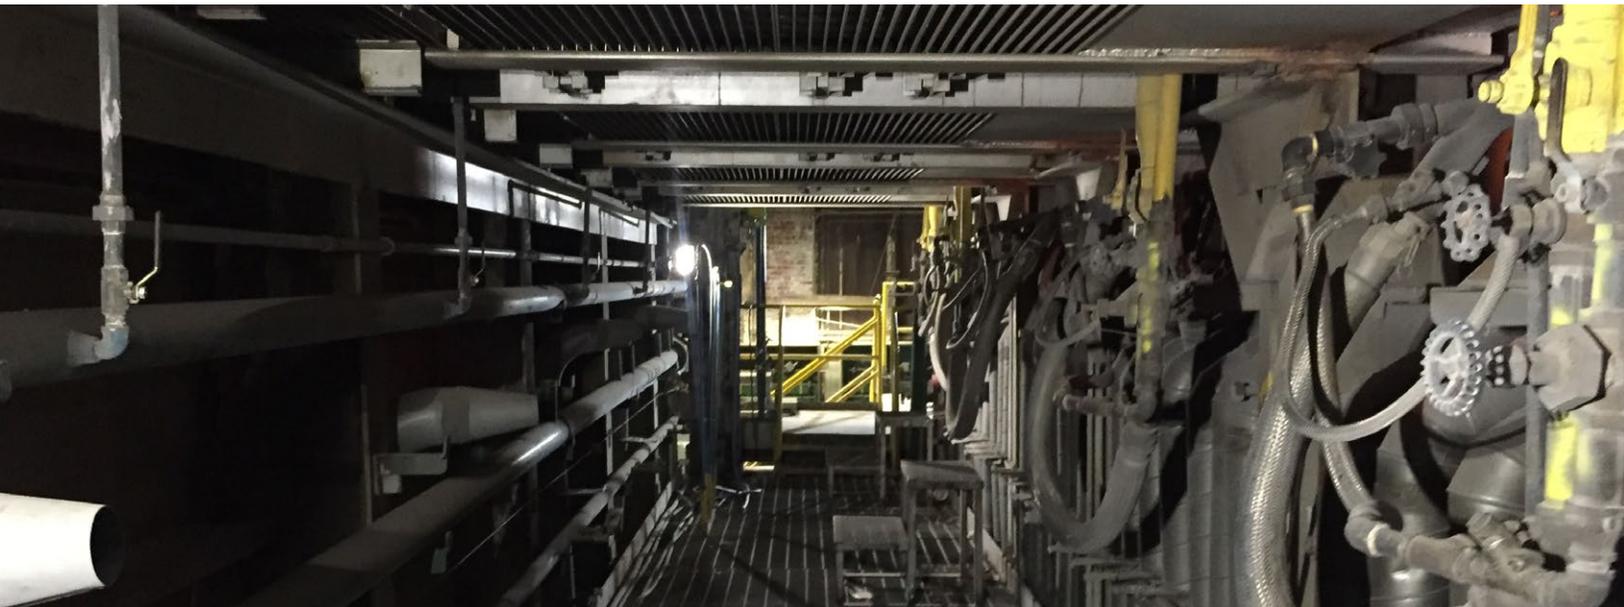
In October 2015, two months before the scheduled overcoat, a SmartMelter® inspection was performed on the furnace. The data from the inspection showed that over two inches (50 mm) of thickness remained at the metal line and the sidewall insulation was secure. Because of this clear picture of the furnace's state and the capability they now had for regular inspection, Libbey made a more confident maintenance decision to postpone the overcoat for another year with a commitment to monitor the metal line and insulated areas regularly.
