SmartMelter advances furnace inspection techniques

Yakup Bayram* discusses a furnace management solution that collects and visualises deterministic data about furnace health using radar technology. The solution has already been validated on several furnaces and gives manufacturers greater gains in furnace maintenance, risk management and a stable production.

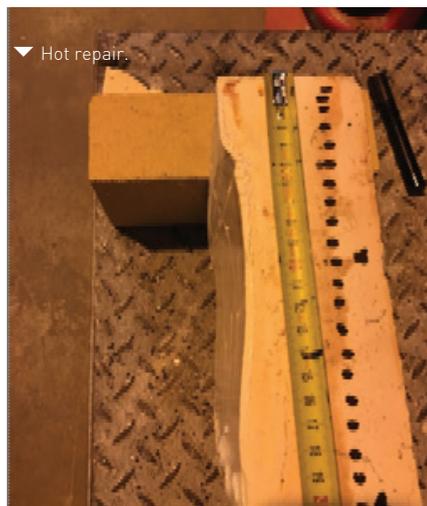
One of the key features of this technology is the ability to perform furnace inspections on an operating furnace without interrupting production. Sensors are designed to be used on the outside of furnace walls in a non-invasive manner. For example, the Refractory Thickness Sensor (RTS) can be placed directly on glass contact refractory such as

fused-cased AZS, high zirconia or Chrome refractories. The interface between the glass and the wall is recorded to produce a measurement of the residual refractory thickness. The Furnace Tomography Sensor (FTS), used on furnace bottom and sidewalls, operates from the outer layer of insulation. The FTS maps early-stage glass penetration and measures the residual thickness of the insulation and refractory layers.
