Furnace Life Optimization Solution

# Refractory Thickness Sensor (RTS) **Blind Trial at a Container Glass Furnace**

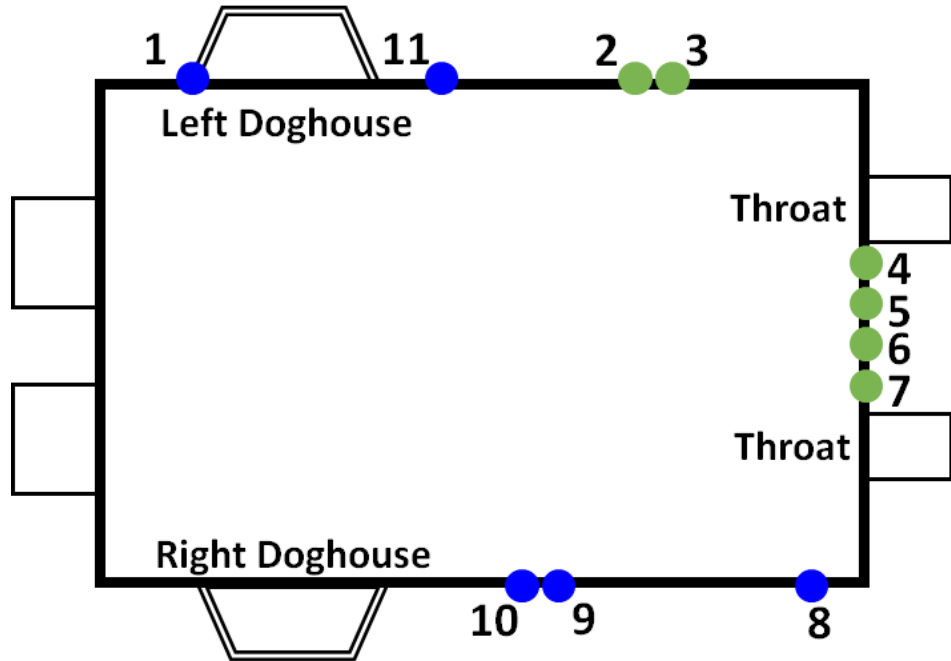
Figure 2  
Furnace Layout and Measurement  
Spots

The Vidrala furnace was an end port-fired furnace. Measurements were taken at two spots near the left doghouse, two spots on the left sidewall, and three spots on the right sidewall. There were also four spots measured in between the two throats. Altogether, eleven areas of the furnace were measured by the RTS sensor.

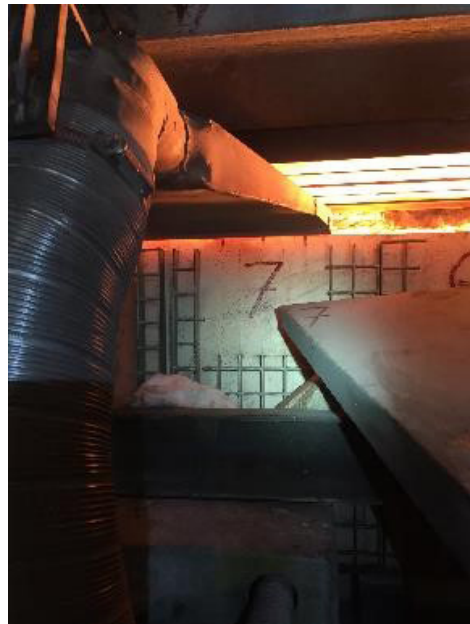
Figure 3  
Each measurement spot was marked  
properly

The measurements were taken with the RTS sensor through fused-cast AZS overcoat blocks (32% AZS) at the metal line. The configuration of the blocks and the measurement process is shown in Figure 4. The PaneraTech team measured through the overcoat blocks at locations shown in Figure 3. Gratings that were holding the overcoat blocks in place were cut prior to measurements to allow for access to the exposed AZS (see Figure 3).

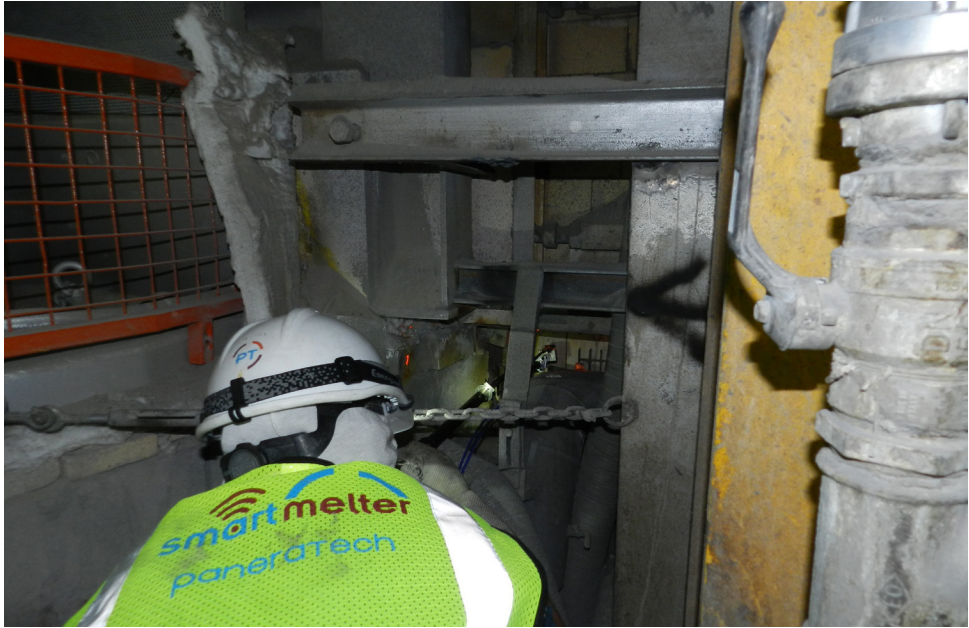
**Figure 4**  
Wall layout at Vidrala furnace

The RTS sensor thickness profile is a vertical scan. It starts about 45 mm (1.7 in) from the very top of the overcoat block to 100 mm (4 in) where the glass line was expected.

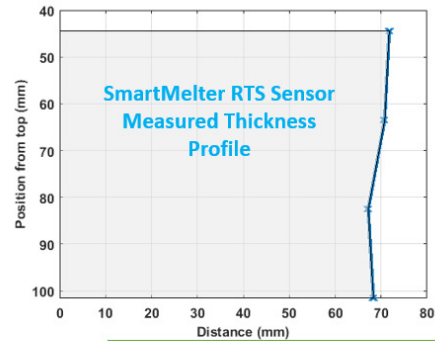
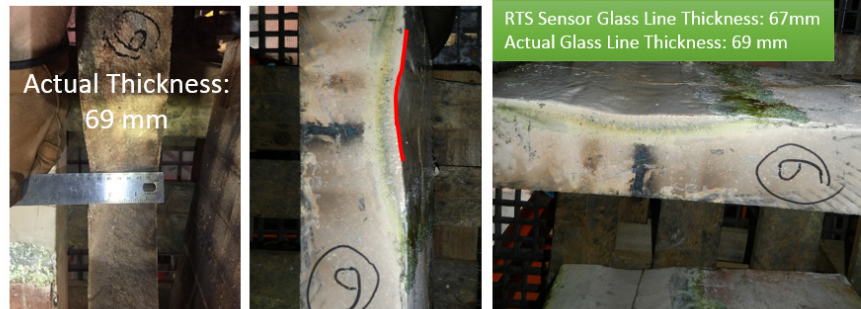
**Figure 6**

After the drain, five blocks were successfully recovered. The other blocks could not be recovered due to the limitation by the construction schedule at the factory. The RTS measurement and actual thickness of one of the spots measured is shown in Figure 6.

The original tank block had completely eroded at the glass level at the measurement spots. The RTS measurements taken from the probe corresponded with the actual erosion profile found in the recovered blocks. The RTS sensor successfully measured the thickness of the residual AZS at the glass line for these five spots within 4 mm (0.15 inch) accuracy as shown in Table I

Comparison of actual block thickness (69 mm) with RTS sensor measured thickness (67 mm) at Spot # 6

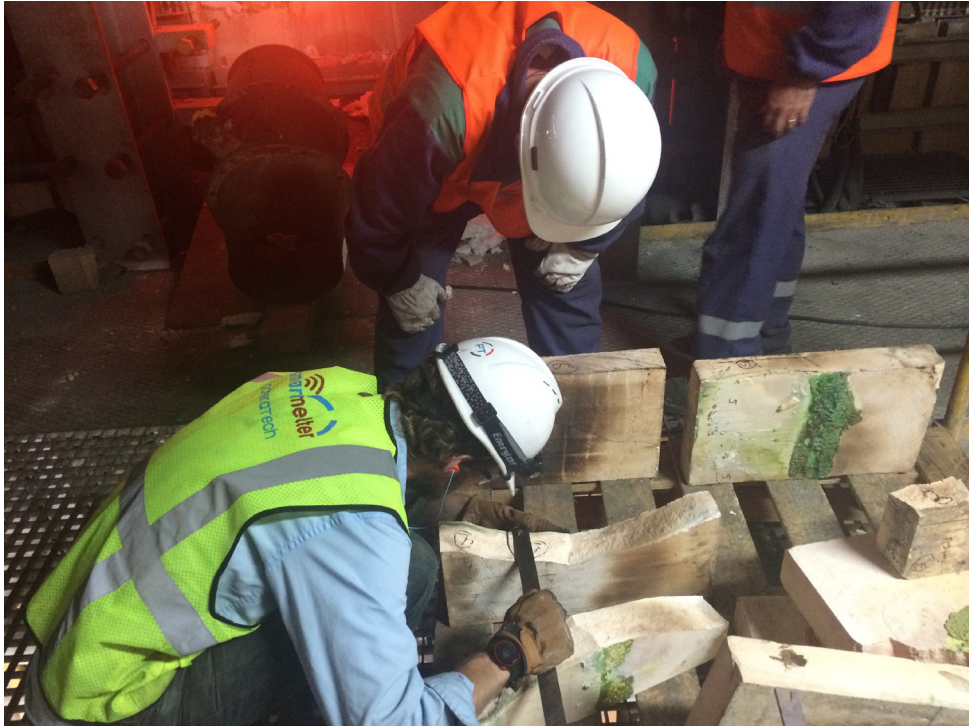
These actual block thickness were measured with Vidrala team as seen in Figure 7.

**Figure 7**  
 Vidrala and PaneraTech team  
 measuring actual wall thickness after  
 the recovery of the blocks.  
 .....
