Furnance Bottom Thickness **Blind Trial at a Float Line**

A major US-based float glass manufacturer approached PaneraTech to use our SmartMelter solution to measure the residual thickness of the furnace bottom on a float line furnace. The float furnace was near the end of the campaign, and the health of the bottom was of great concern for the manufacturer. Eight months before the planned shutdown date, PaneraTech performed an initial assessment of the furnace bottom. PaneraTech performed several surveys leading up to the planned shut-down to map the residual thickness of the furnace bottom.

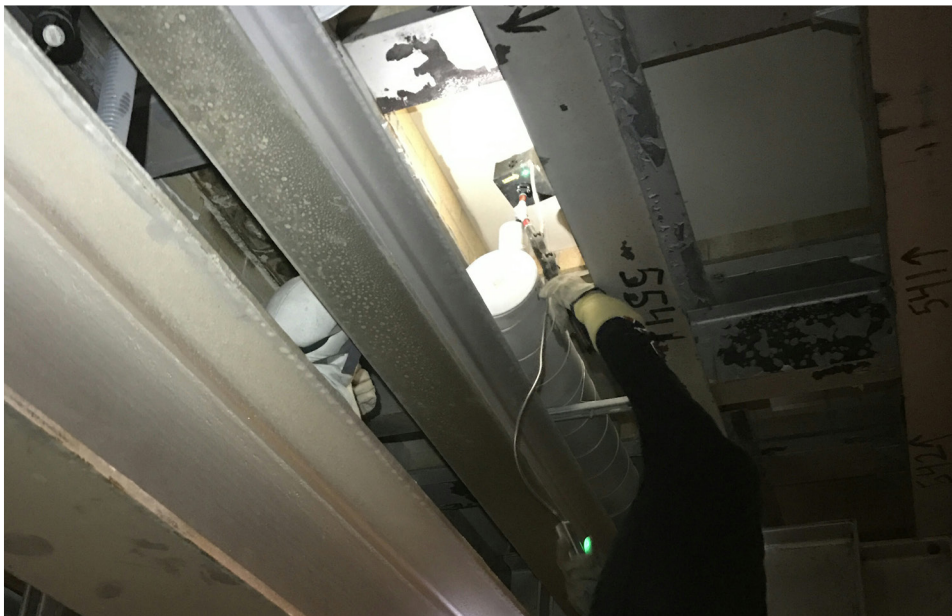
Figure 1
SmartMelter Furnace Bottom
Inspection at a Float Line

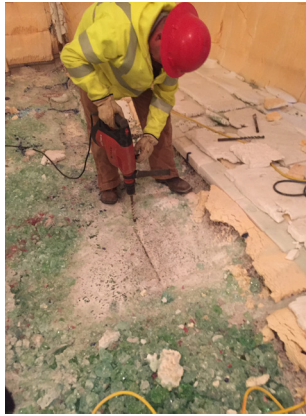
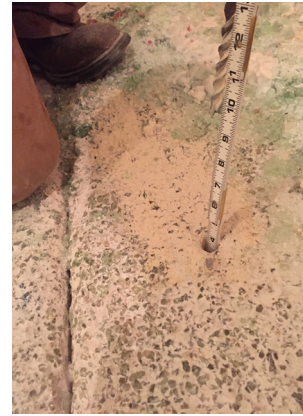
Figure 6

After the drain, several spots were chosen by the float glass manufacturer for comparison with the SmartMelter results. The remaining cold glass was removed and these spots were drilled. The actual thickness of each block was measured by the float line manufacturer team. In the spots that were examined, the original AZS paver blocks had eroded and glass had penetrated into the clay flux. The SmartMelter sensor successfully measured the thickness of the residual clay flux for these five spots within 0 - 5 mm (0.2 inch) accuracy as shown in Table 1. The five blocks had residual thicknesses of 99 mm to 208 mm.

Validation of SmartMelter with glass removal, drilling and measurement of actual thickness
