Furnace Life Optimization Solution

# Refractory Thickness Sensor (RTS) **Blind Trial at a Float Line**

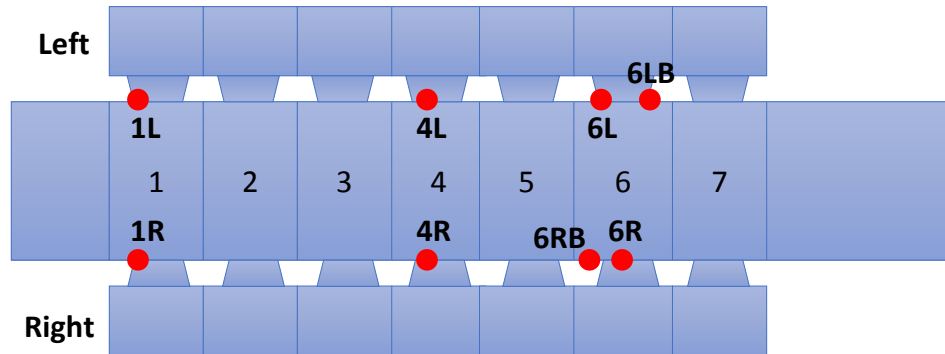
Figure 2  
Furnace Layout and Measurement Spots

The float line furnace was a cross-fired furnace. Measurements were taken on a total of 8 blocks (see Figure 2) at both left and right side of ports 1, 4 and 6.

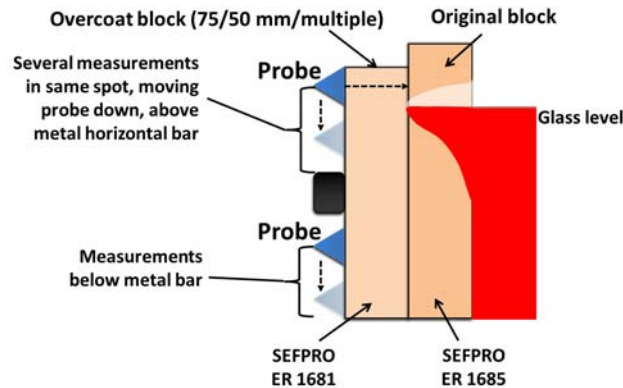
Figure 3  
Wall Layout at Float Furnace

The overcoat blocks were supported by a horizontal metal bar in the middle. The measurements were taken with the RTS sensor through fused-cast AZS overcoat blocks (32% AZS) at the metal line (above the metal bar in the middle) and also below the metal bar (see Figure 3). The configuration of the blocks and the measurement process is shown in Figure 3. Depending on the location at the port, the overcoat blocks had thicknesses ranging from 50 mm (2in) to 75 mm (3 in). In some locations, there were multiple overcoat blocks.

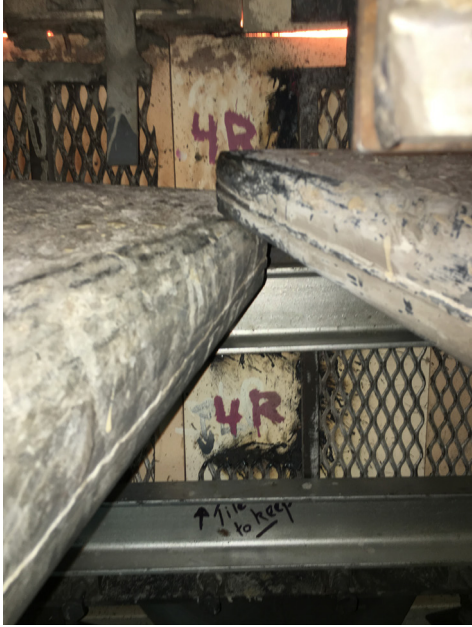
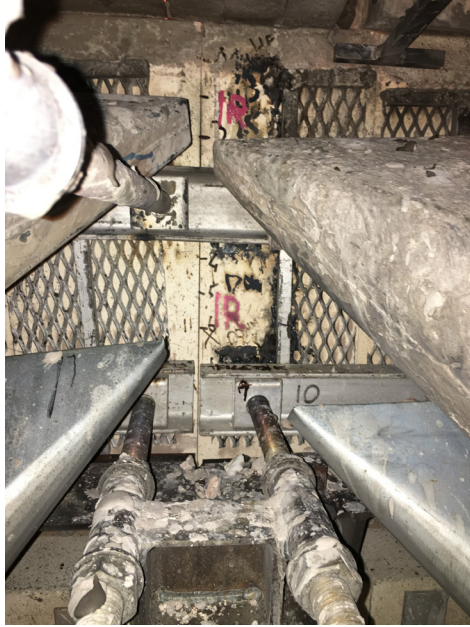
**Figure 4**  
Each measurement spot was marked properly

Gratings that were holding the overcoat blocks in place were cut prior to measurements to allow for access to the exposed AZS as shown in Figure 4.

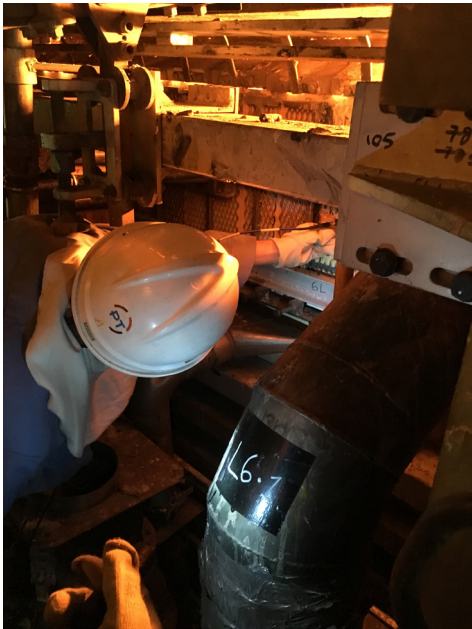
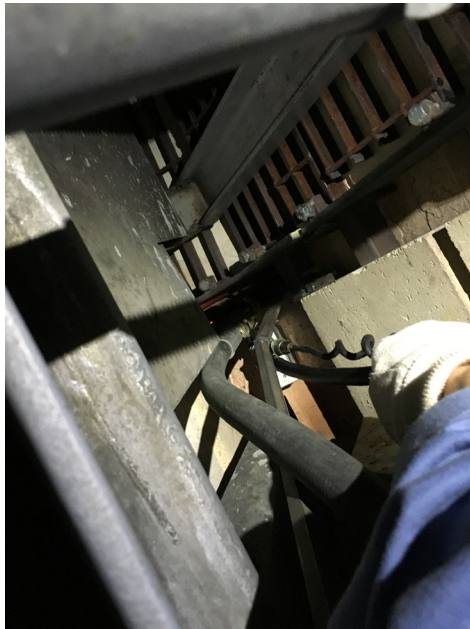
**Figure 5**  
PaneraTech team member taking measurements on the furnace

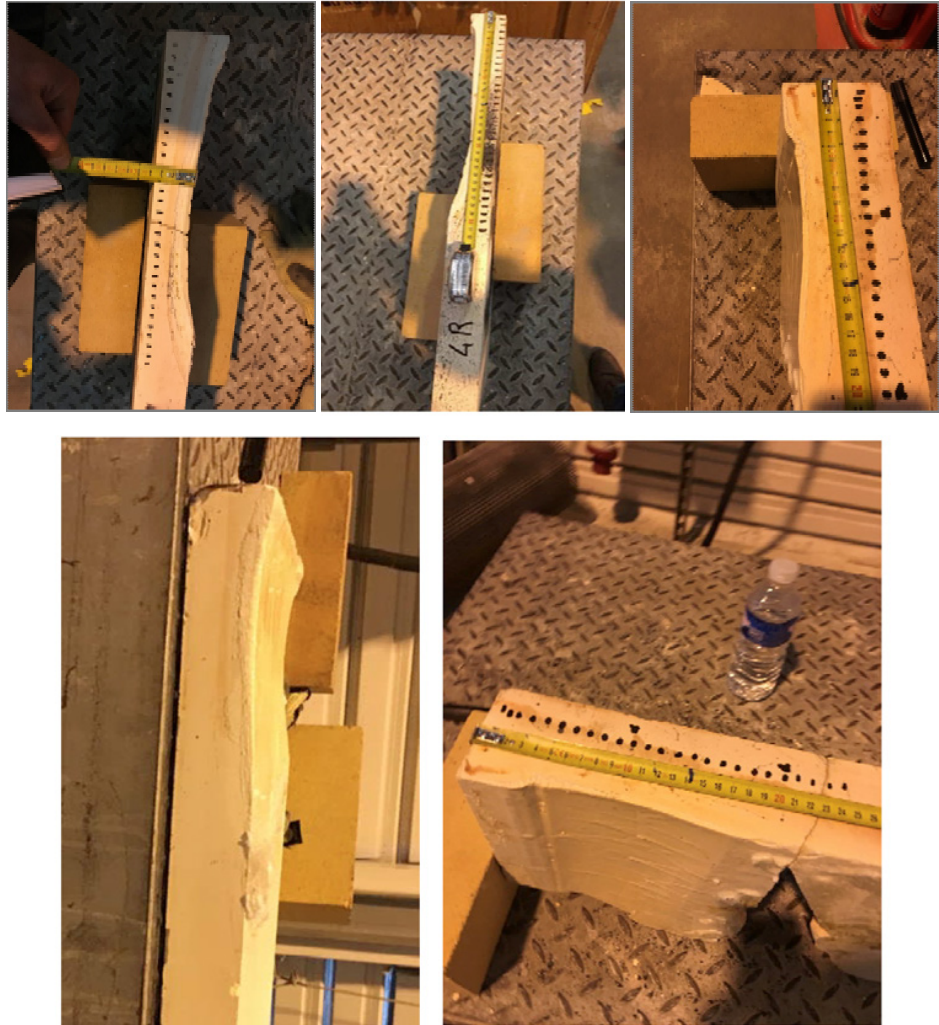
**Figure 6**

After lowering the glass level, all of the blocks were successfully recovered. The actual thickness of each block was measured with the float line manufacturer team. The original tank block had completely eroded at the glass level for most of the blocks.

Pictures of Some of the Blocks  
Recovered During Hot Repair

The RTS sensor successfully measured the thickness of the residual AZS for these five spots within 0-5 mm (0.2 inch) accuracy as shown in Table 1.
